Manhole Inspection Summary

Manhole # S39W1_013MH

Insp Date: **11/20/07 8:28 AM**

Location Address: **3554 Helmstetter**

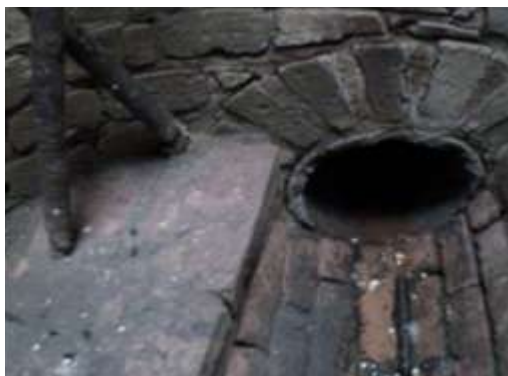
Defect 3

Debris

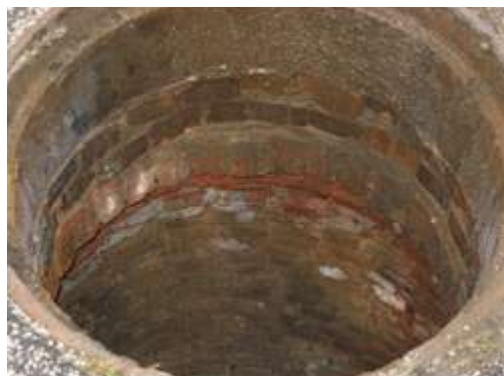
Defect 2

Condition: ☐ Sound ☒ **Cracked** ☐ Root Intrusion ☐ Loose Brick ☐ Deteriorated

Infiltration: ☐ None ☐ Joint ☒ **Cracks** ☒ **Mortar** ☐ Roots ☐ Wall

Chimney cracks

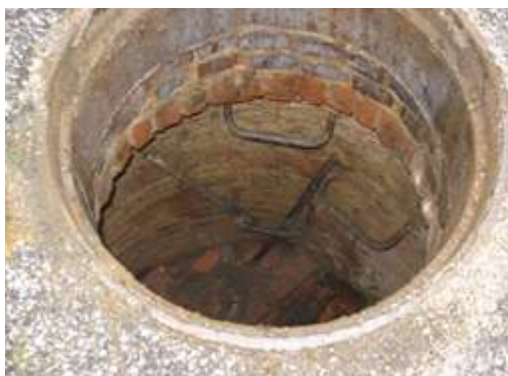
Defect 1

Debris

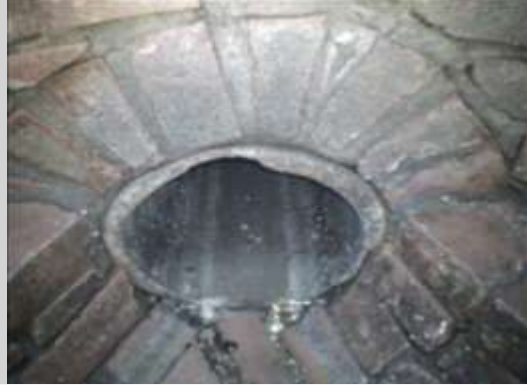
12 O'Clock Outflow

8 in. Circular Gravity Sewer
Pipe Out @ 12 O'Clock

Pipe Height: **10.8** (in.) Rod and Bar (Angled)
Pipe Material: **Clay** ☐ Pipe Lined
Invert Depth: **7.48** (ft.) Flow Characteristics: **Slow**
Deposits: ☐ None ☐ Mud ☐ Sludge ☒ **Debris** ☐ Grease
Silt Depth: **0.5** (in.) Deposits Extent: **Light**
Infiltration: **None** Pipe Seal Cond: **Sound**

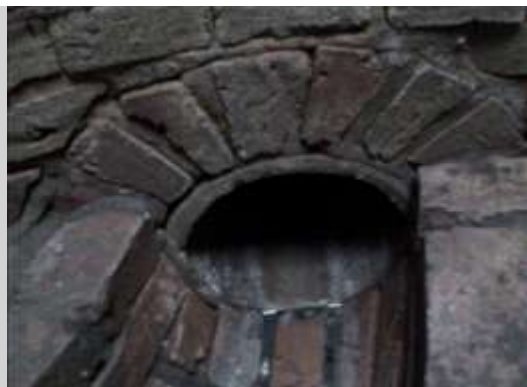
3 O'Clock Inflow

6 in. Circular Service Sewer
Pipe In @ 3 O'Clock

Pipe Height: **10.8** (in.) Rod and Bar (Angled)
Pipe Material: **Clay** ☐ Pipe Lined
Invert Depth: **7.51** (ft.) Flow Characteristics: **Slow**
Deposits: ☐ None ☐ Mud ☒ **Sludge** ☐ **Debris** ☐ Grease
Silt Depth: **0.5** (in.) Deposits Extent: **Light**
Infiltration: **None** Pipe Seal Cond: **Cracked**

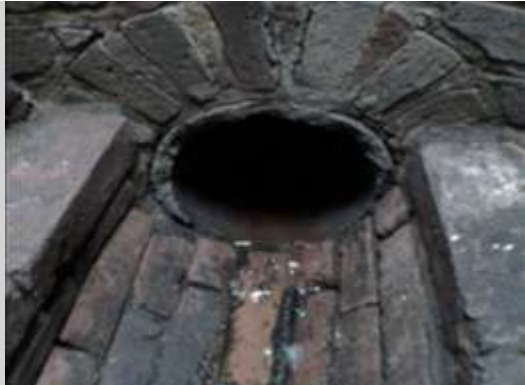
6 O'Clock Inflow

6 in. Circular Service Sewer
Pipe In @ 6 O'Clock

Pipe Height: **10.8** (in.) Rod and Bar (Angled)
Pipe Material: **Clay** ☐ Pipe Lined
Invert Depth: **7.33** (ft.) Flow Characteristics: **Slow**
Deposits: ☐ None ☐ Mud ☐ Sludge ☒ **Debris** ☐ Grease
Silt Depth: **0.5** (in.) Deposits Extent: **Light**
Infiltration: **None** Pipe Seal Cond: **Sound**

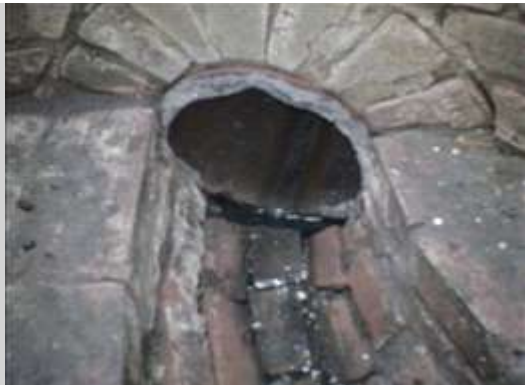
8 O'Clock Inflow

8 in. Circular Gravity Sewer
Pipe In @ 8 O'Clock

Pipe Height: **9.6** (in.) Rod and Bar (Angled)
Pipe Material: **Clay** ☐ Pipe Lined
Invert Depth: **7.31** (ft.) Flow Characteristics: **Slow**
Deposits: ☐ None ☐ Mud ☐ Sludge ☒ **Debris** ☐ Grease
Silt Depth: **0.5** (in.) Deposits Extent: **Light**
Infiltration: **None** Pipe Seal Cond: **Sound**
